CVS/pharmacy
#08885 GOLDEN WEST & McFADDEN
HUNTINGTON BEACH, CALIFORNIA

CVS - HUNTINGTON BEACH

Project Elements	1
Summary	2
Background	3
Description of Trees: Size and Condition.....	4
Description of Trees: Photographs.....	8
Tree Location Map, Initial Feasibility Study Plan.....	17
Tree Location Map, Revised Feasibility Study Plan	18
Tree Preservation Measures; Mitigation	19
Consultant Qualifications

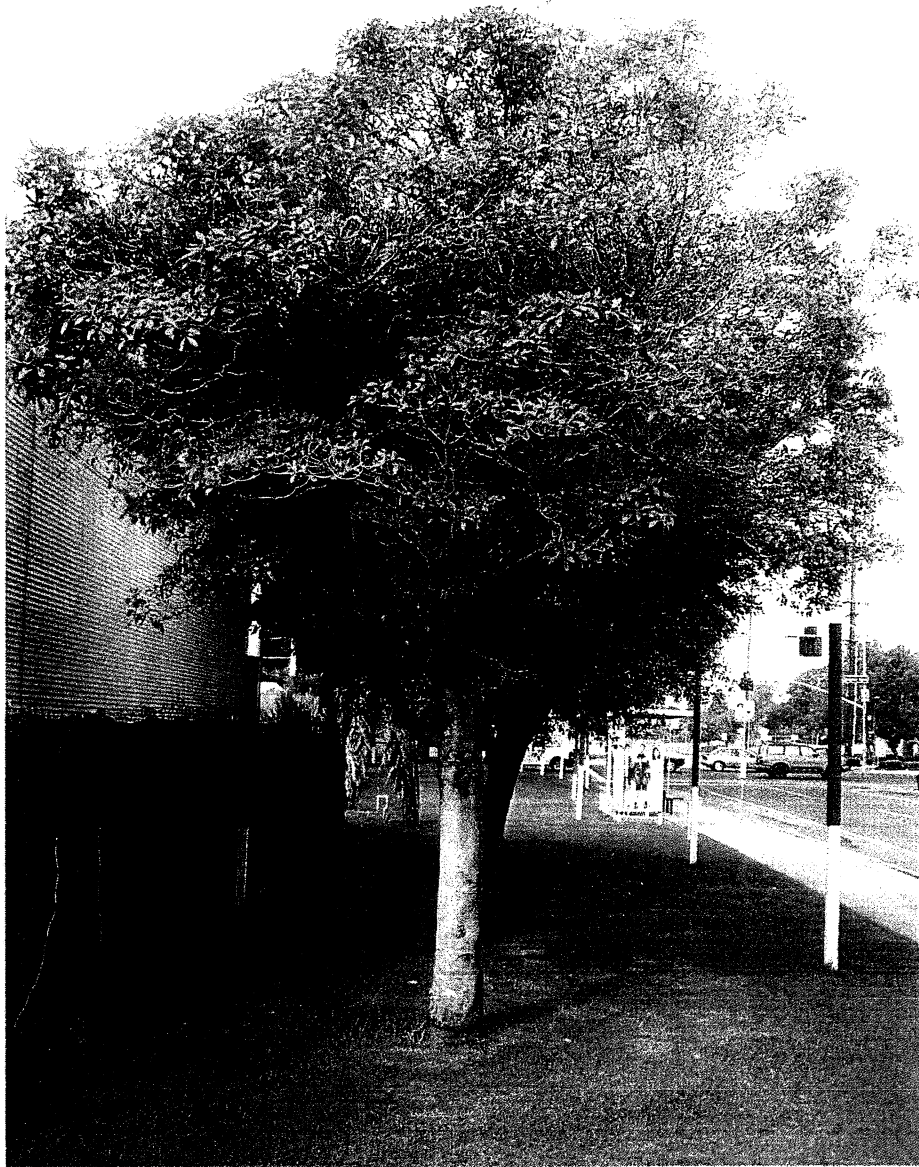
1. Victorian box. Trunk diameter 10 inches at 4.5 feet above ground. Height and spread estimated as 18 x 18 feet. Condition rating 35% (poor). Estimated life expectancy 5 to 10 more years.

1. Tree no. 1. Victorian box.

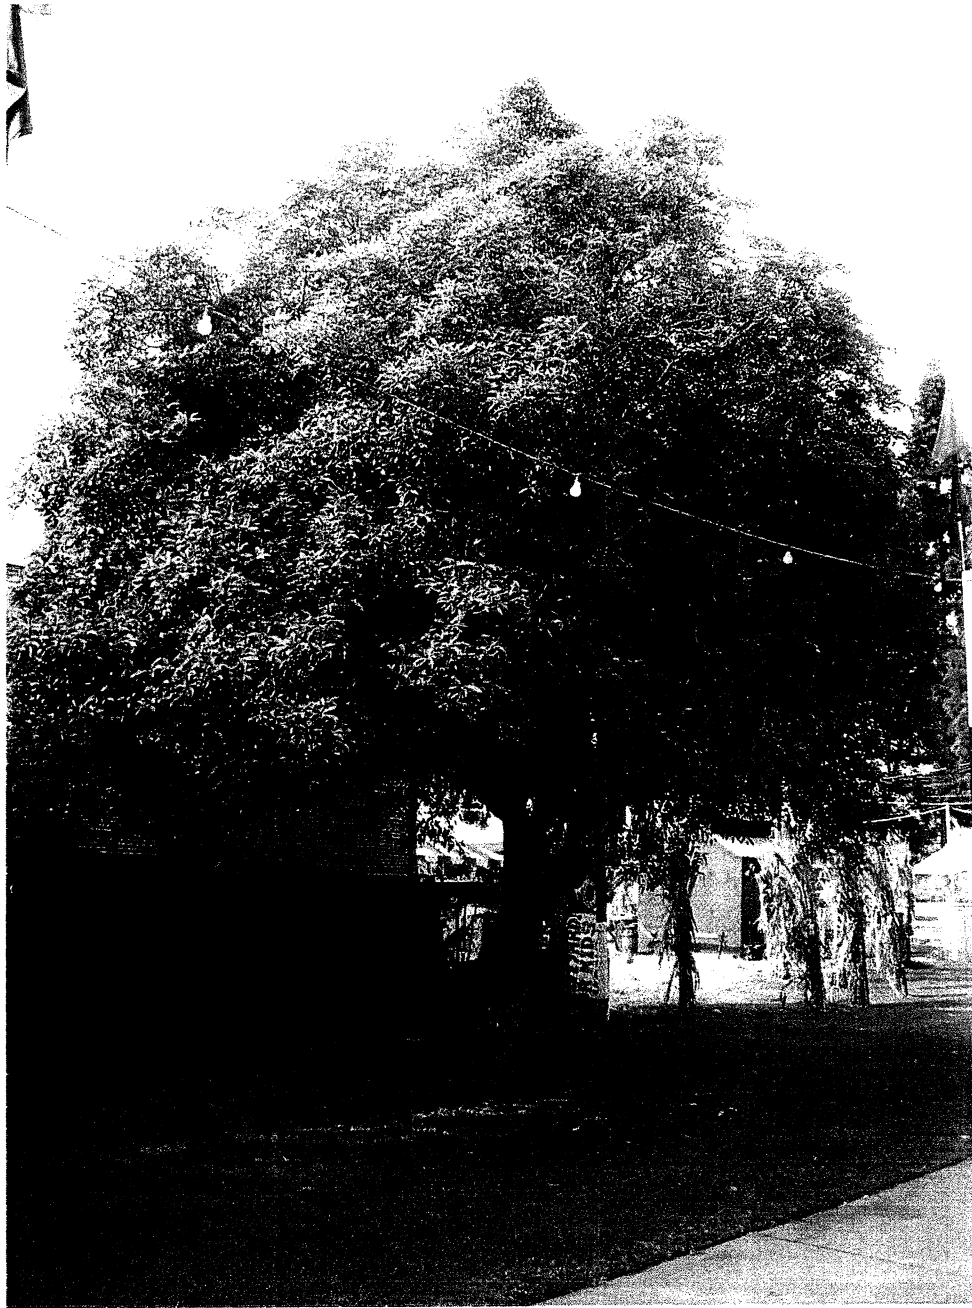
2. Victorian box. Trunk diameter 13 inches at 4.0 feet. The trunk had divided into 5 branch stems at about 5 feet above ground. Condition rating 55% (below average). Estimated life expectancy 20-50 more years.

2. Tree no. 2. Victorian box.

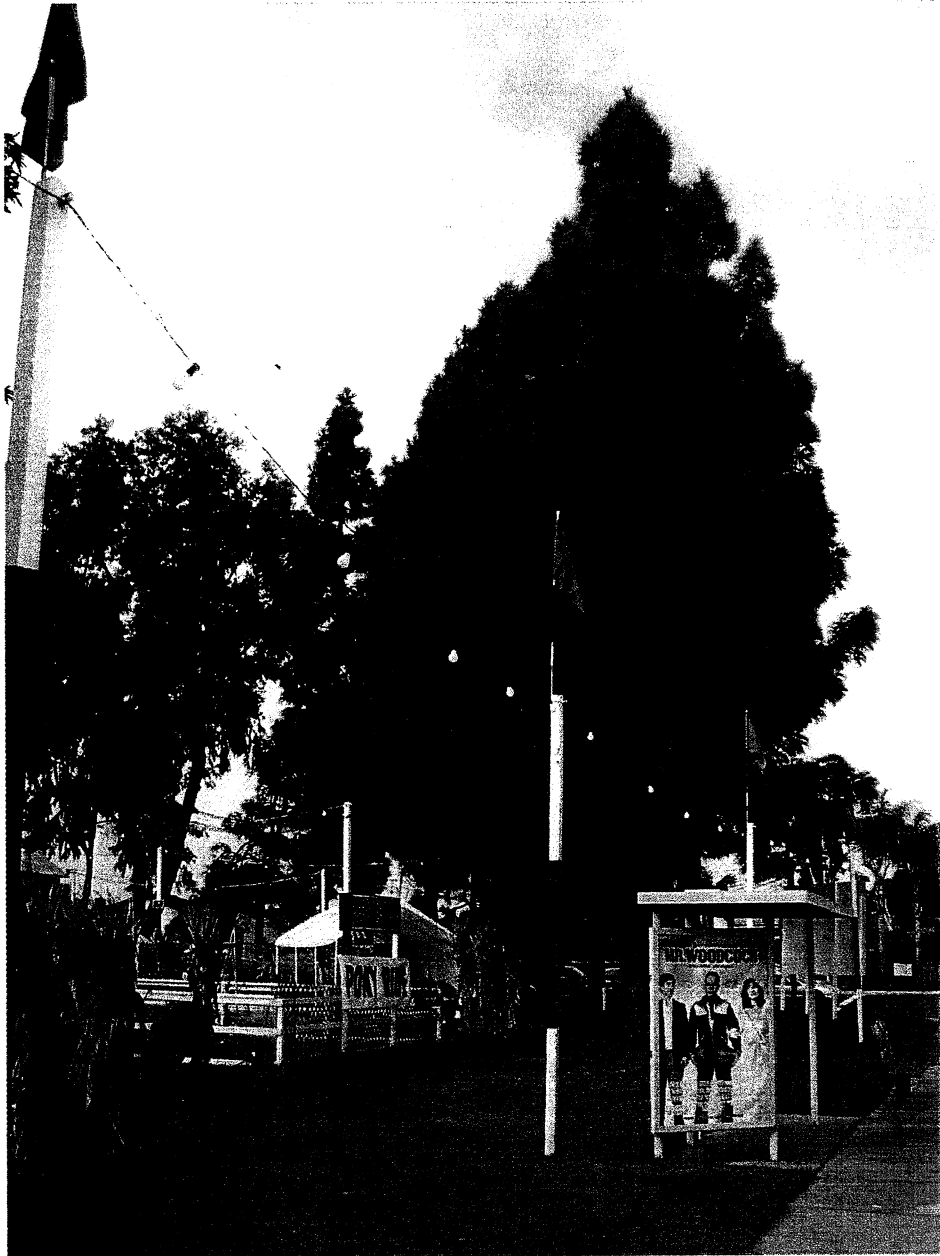
3. Canary Island pine. Trunk diameter 18 inches at 4.5 feet. Height and spread estimated as 60 x 18 feet. Condition rating 70% (high average). Estimated life expectancy 25-60 more years.

3. Tree no. 3. Canary Island pine.

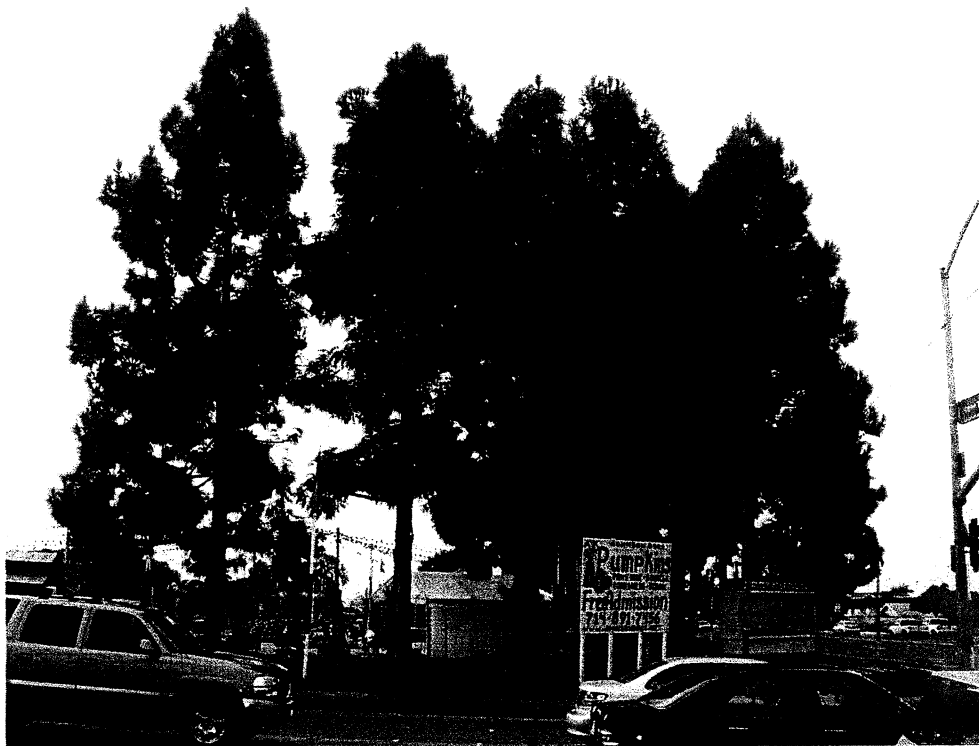
4. View from north side of McFadden Avenue. From left to right, trees no. 3, 4, 5, 6, 7.

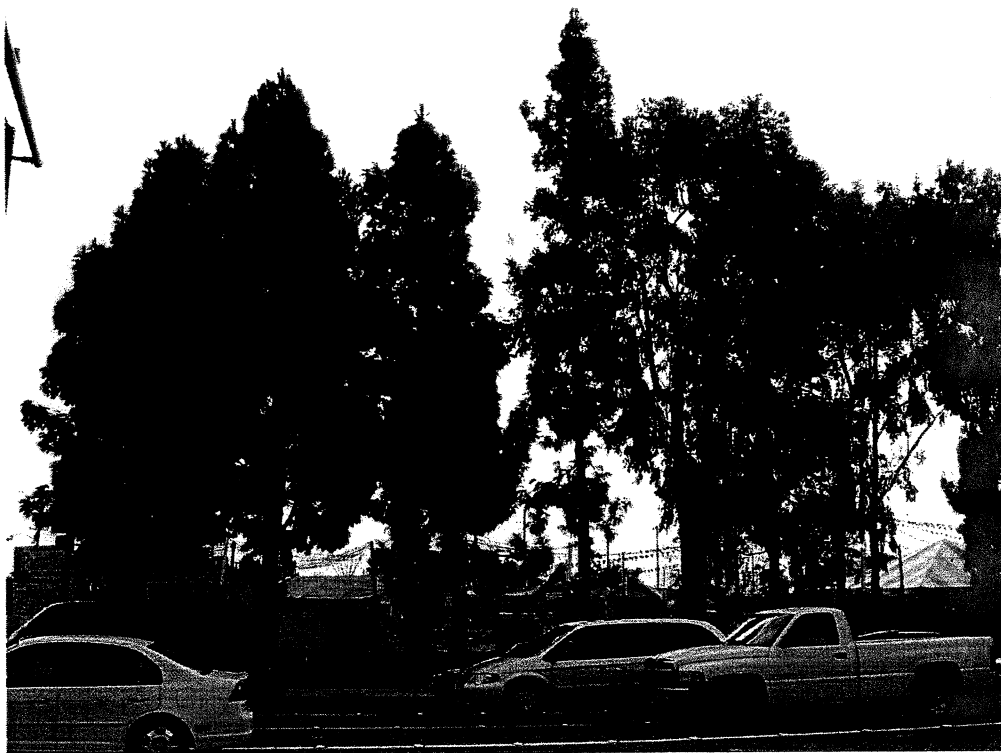
5. View from west side of Goldenwest Street. The cluster of Canary Island pines at left includes trees no. 3-8. The tall Canary Island pine in the middle is no. 9. To the right of it is no. 10, a Pink ironbark, then Pink ironbarks no. 11-13.

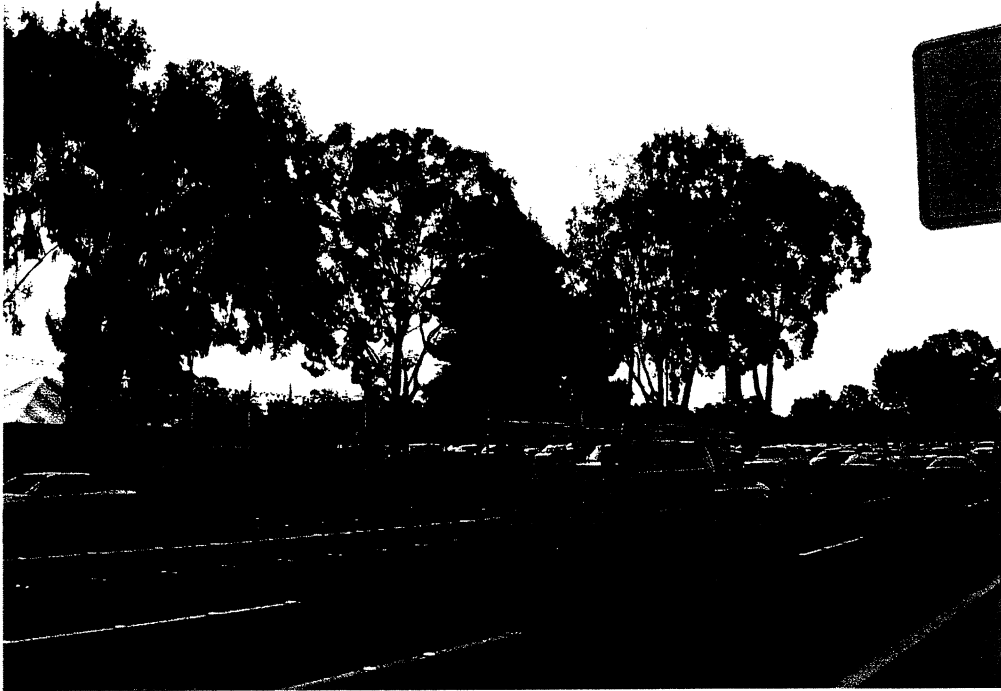
6. South end of the stand, viewed from the west side of Goldenwest Street. Left to right, no. 14, Pink ironbark; no. 15, Lemon gum; nos. 16 and 17, Aleppo pines; nos. 18 and 19, Lemon gums. The Lemon gum at the extreme right is not on the study site.

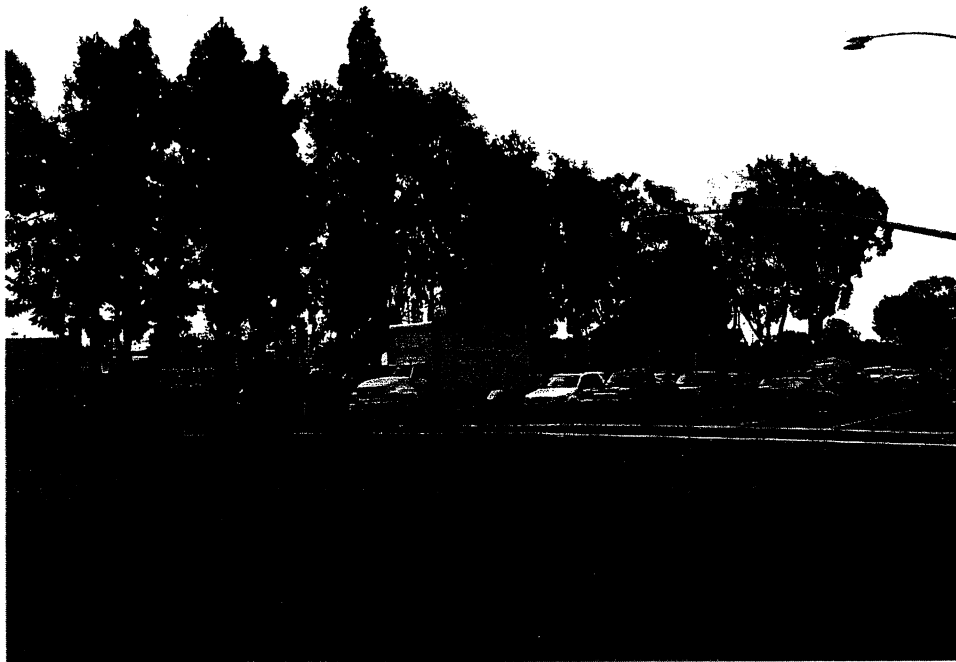
7. View of the tree stand along Goldenwest Street. If the Feasibility Study plan is adopted as designed, the esthetic, environmental, social and psychological benefits of this entire grove will be eliminated.

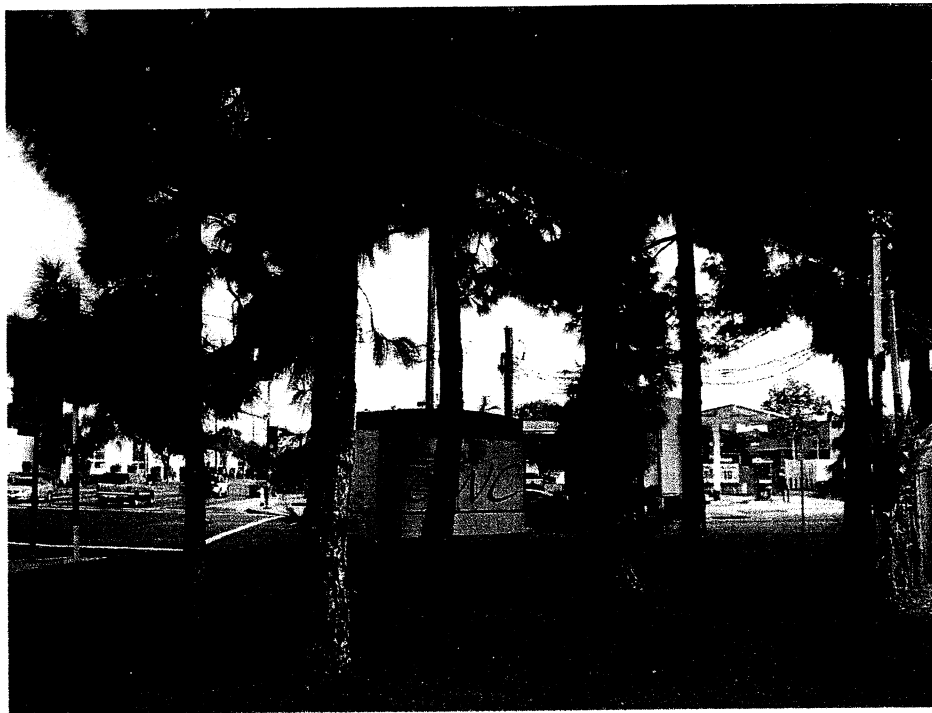
8. View from south of trunks of Canary Island pines no. 4-9.

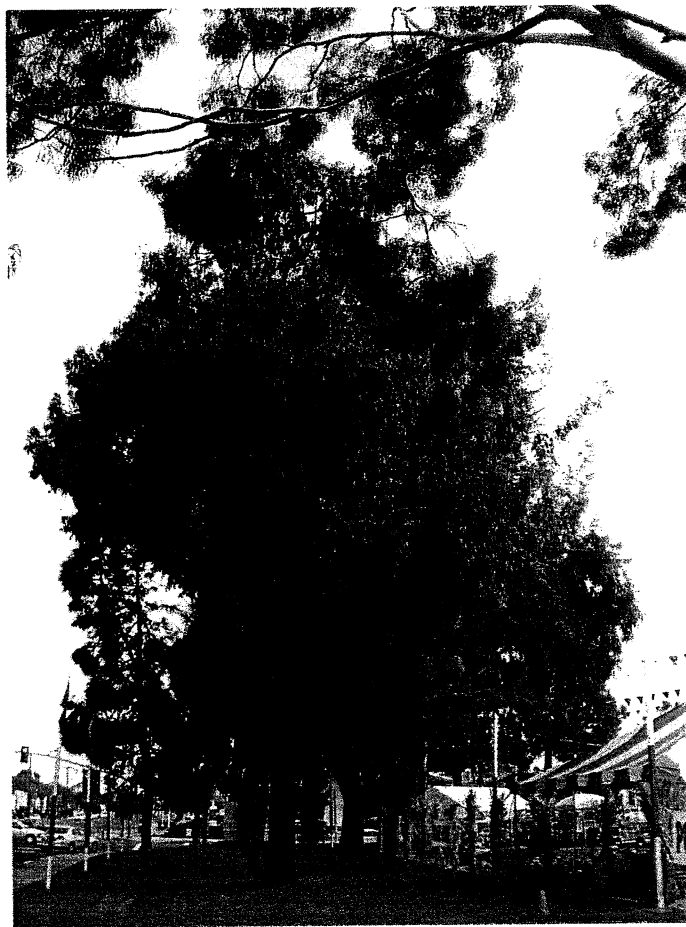
9. View from south of Pink ironbarks no. 10 and 14. Canary Island pine no. 9 is at left.

In other words, to assure reasonable stability (to avoid the potential for toppling under strong wind conditions) tree no. 10 should have an undisturbed root zone of 28 feet in diameter, and 13 feet on the side toward the east end of the bed. No. 15 would need a bed 24 feet wide, with 11 feet between the trunk base and the east end of the bed.

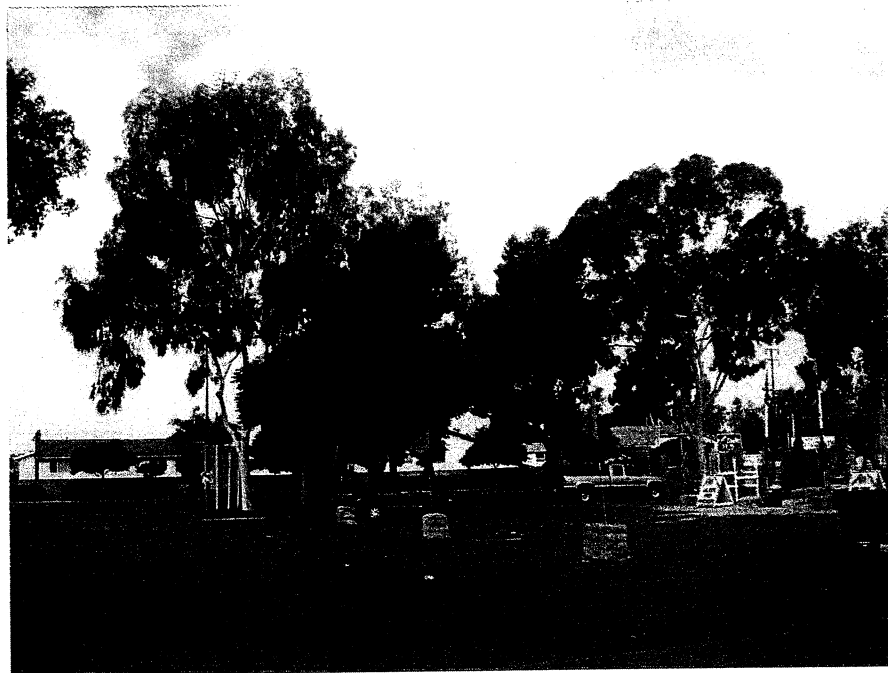
10. South end of tree stand, viewed from east side. Right to left: no. 15, Lemon gum; nos. 16 and 17, Aleppo pines (midground); no. 21, Jacaranda (foreground); no. 20, Lemon gum.

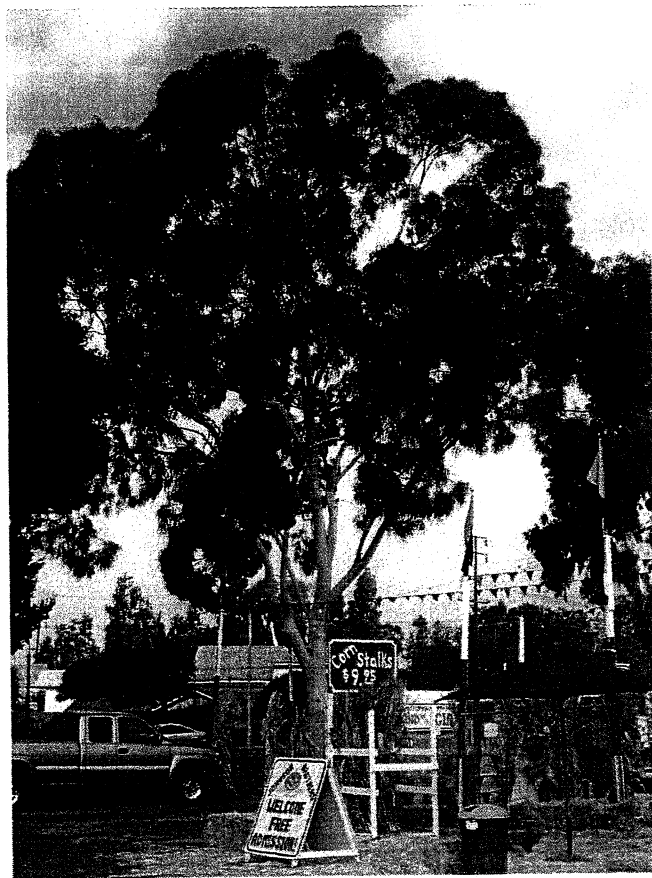
15. Lemon gum. Trunk diameter 23.5 inches at 4.5 feet. Height and spread estimated as 75 x 60 feet. Condition rating 75% (superior). Estimated life expectancy 50-100 more years.

11. No. 15, Lemon gum.

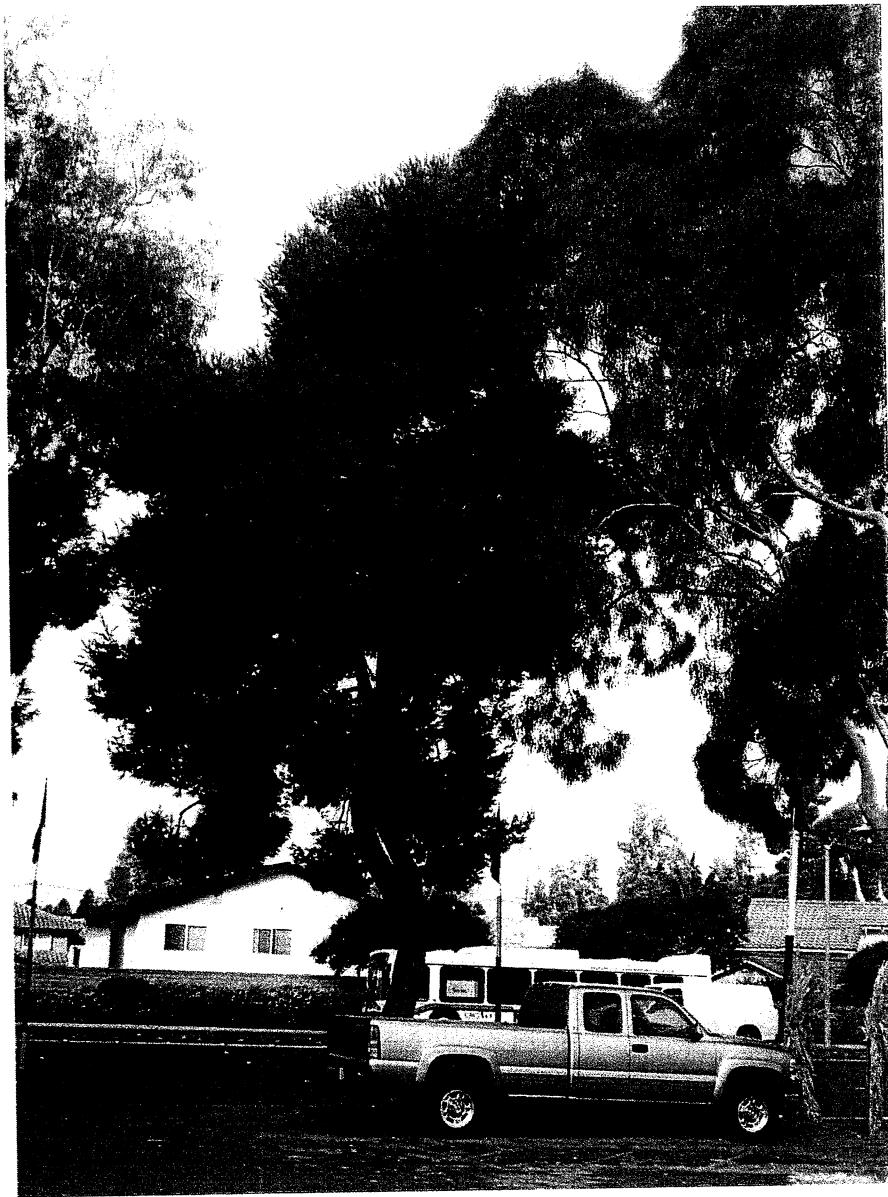
16. Aleppo pine. Trunk diameter 19.3 inches at 4.5 feet. Height and spread estimated as 55 x 23 feet. Condition rating 70% (high average). Estimated life expectancy 30-60 more years.

12. No. 16, Aleppo pine.

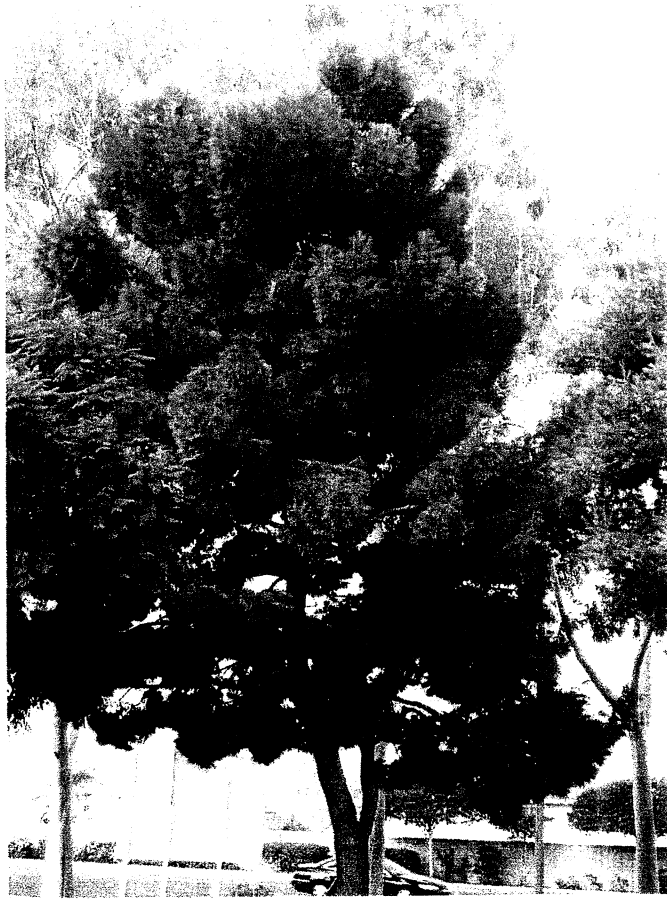
17. Aleppo pine. Trunk diameter 18 inches at 4.5 feet. Height and spread estimated as 55 x 30 feet. Condition rating 70% (high average). Estimated life expectancy 30-60 more years.

13. No. 17, Aleppo pine.

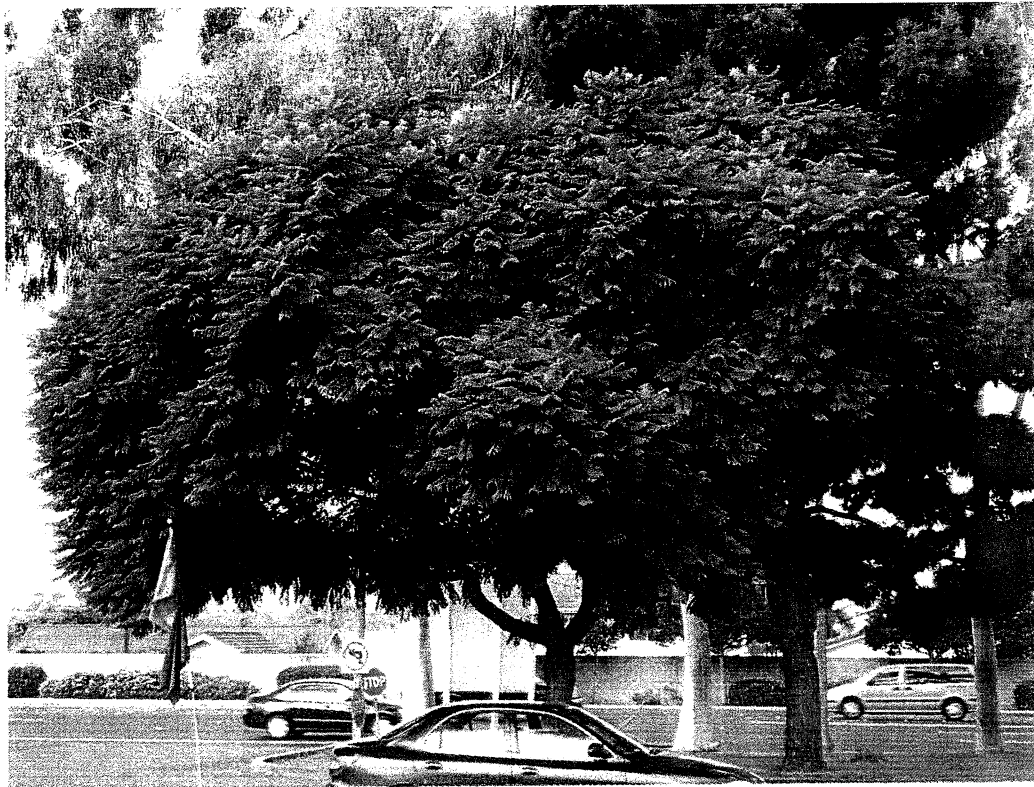
21. Jacaranda. Trunk diameter 12 inches at 4.5 feet. Height and spread estimated as 25 x 28 feet. Condition rating 70% (high average). Situated in a 40-inch-wide planting bed in a parking area. Estimated life expectancy 25-35 more years.

14. No. 21, Jacaranda.
